Case Study

Brighton Bandstand

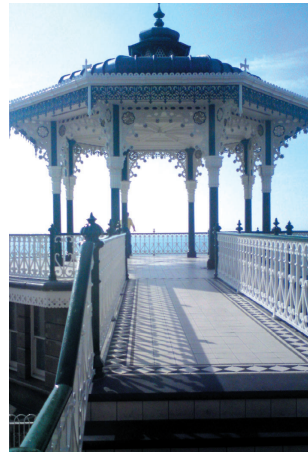
The run down dilapidated basement of the building was very wet and damp, and remedial works included grit blasting the soffits, walls, and floors together with the badly corroded supporting filler joists.

Once all the preparation works had been completed, Cemplas then went about undertaking reinstatement of all the remedial concrete repairs.

On completion of the concrete repairs, the basement floor and walls were fully waterproofed with an epoxy tanking system, and a DPC was injected into both the external perimeter & internal walls.
