Case Study

Earls Court

Earls Court surveyors having noted the Warwick Road Basement Concourse was showing visible signs of delaminating concrete, called upon the expertise of Cemplas to investigate the extent of the defects.

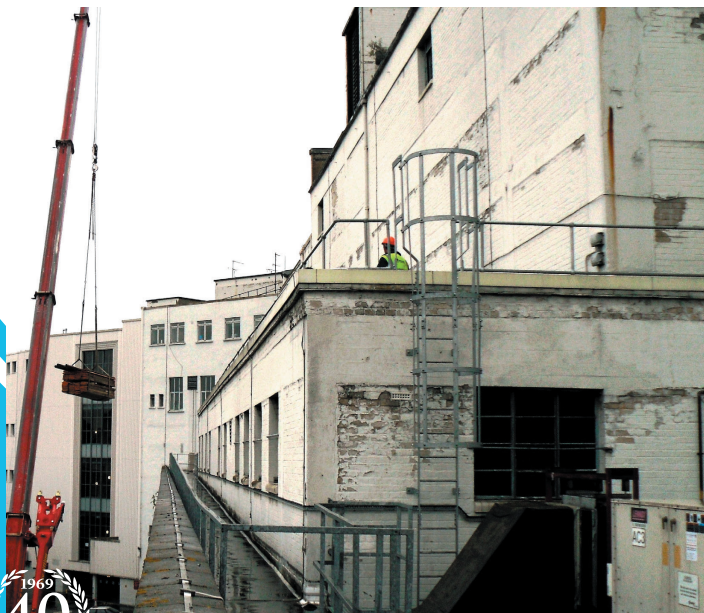
Earls Court facade before and after

Following a detailed survey, a full Jet wash of the substrate, followed by detailed hammer testing to all areas was undertaken to determine the full extent of required repairs.

Areas were marked out in a series of straight lines to form a border around defective area including any hairline cracking. Defective areas were the Saw cut at right angles along previously marked lines to a minimum depth of 10 mm.

All defective concrete was removed. Where the steel reinforcement bar had been exposed and was corroded, the concrete was removed to a depth of 20 mm behind the bar, and the concrete around the exposed corroded reinforcement bar was removed until 50 mm of clean steel could be achieved at both ends of the rebar.

All corrosion was removed to achieve BS7079: Part A1, and two coats of Fosroc Nitoprime Zincrich steel reinforcement protector was applied to the previously cleaned reinforcement bar.

The area to be reinstated was firstly primed with Nitobond HAR, and whilst still tacky, Fosroc's Renderoc HB Repair Mortar was applied to match the existing surface, and the mortar cured with Nitobond AR.

Cracks to concrete and brick works were resin injected with Fosroc Nitokit Surface Sealant. Defective bricks were replaced, re-pointed and stitched where required.

On completion of the remedial repairs, Fosroc's Anti-carbonation coating was applied to provide a decorative protective finish.
