# Car Parks – Case Study

Retail Shopper Car Park Refurbishment

Morrisons Store Rooftop Car Park,  
Herne Bay, Kent

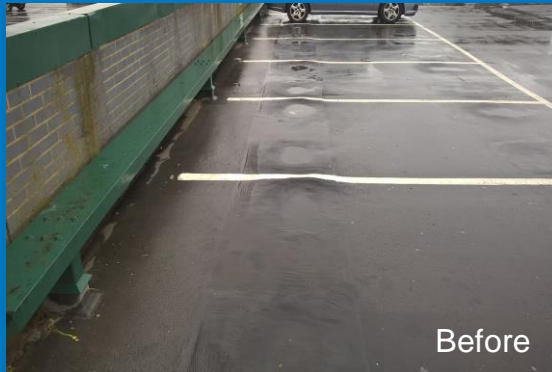
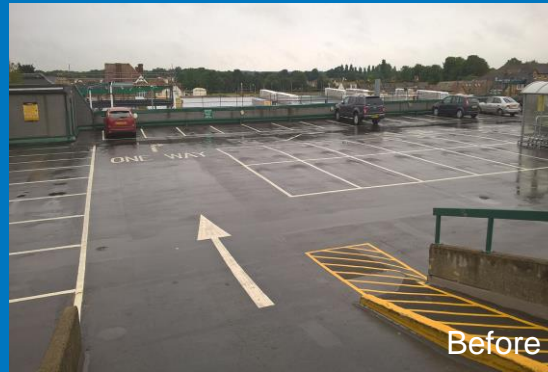
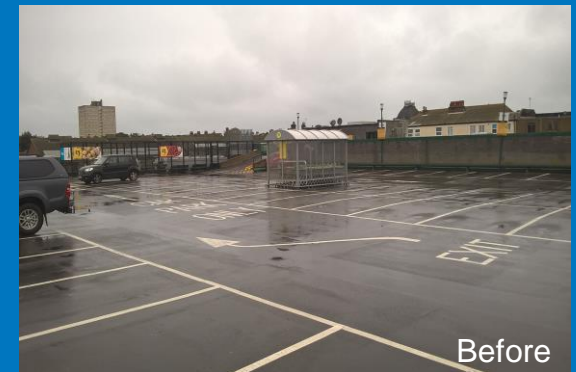
Before

The car park at Morrisons Herne Bay is located on the roof of the retail store itself and is split over two levels providing approximately 80 spaces. The existing asphalt waterproof wearing surface of the car park had become badly damaged and split over the years and was allowing significant water ingress into the store below. The asphalt itself – covering some 2,500m<sup>2</sup> – was prepared by planing & captive blast to remove surface imperfections & linemarkings and to provide a suitable mechanical key for the application of a new waterproofing system on top.

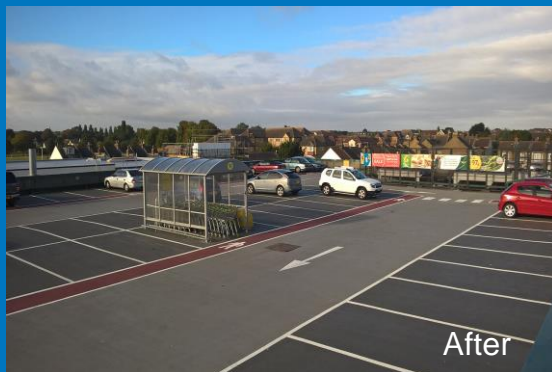
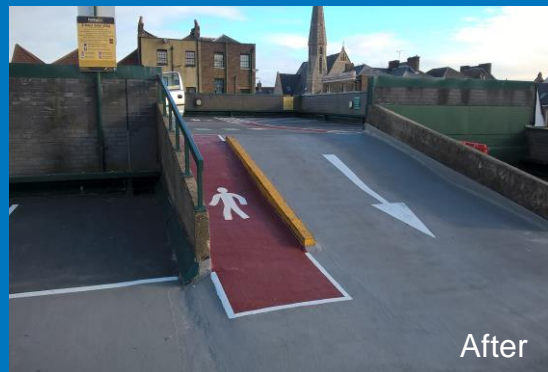
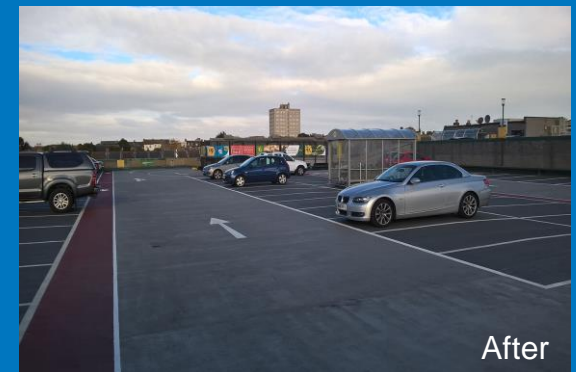
After

Sika's fully-reinforced Pronto 32 system was applied to all areas including up / down ramps. Cemplas also carried out localised concrete repairs to the semi-circular vehicular access ramp.
