Case Study

Northminster Multi-Storey Car Park

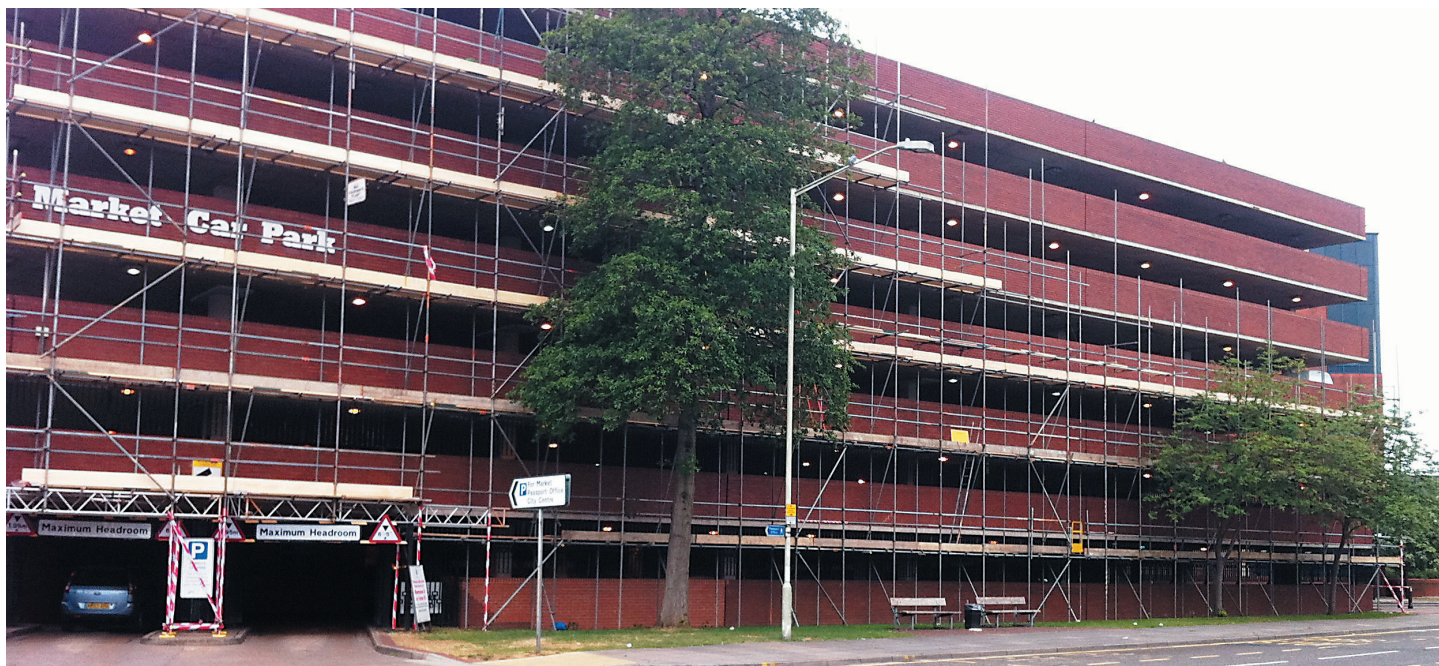
Working as the principle main contractor for Peterborough Council, **Cemplas Waterproofing and Concrete Repairs Ltd** were appointed to undertake a range of remedial work which included concrete repairs, brick wall ties, and car park surface repair and coating.

Works commenced with the erection of scaffold to all elevations, and Concrete Repairs were carried out using Sika Monotop 610. The external concrete beam face and concrete soffits were repaired with Sika Monotop 615, & Sika Set 45 Rapid Concrete Repair Mortar was used on the concrete floor slabs. Isolated areas to the existing top deck coating were removed, and Sika Proto surface coating applied.

Following a survey to test the structural integrity of the parapet walls, Cemplas operatives were tasked with installing in excess of 10,000 new Helifix Rectrotie brick ties to the parapet walls on all the car park levels.
